# TRAINING NOTES

### Louis Mambretti Fire | Garage Door Operations

March 9, 1995  
75 Everson Street, San Francisco

One firefighter killed and eleven others injured, one critically, fighting a residential fire in the Diamond Heights neighborhood. Three firefighters were trapped when an overhead garage door closed behind them without warning

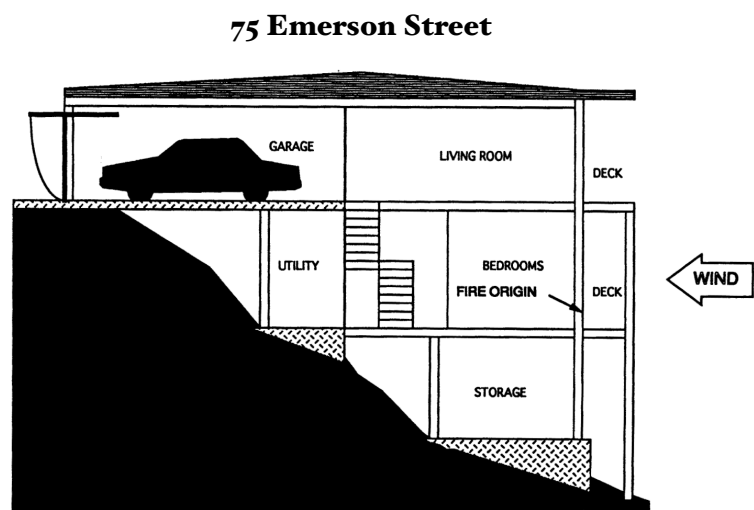
Figure 1a

While in the process of advancing through the garage into the home, Engine 26 encountered heavy smoke and fire conditions while making their way to the stairs and the decision was made to back out of the garage. While attempting to exit the garage, Lt. Mambretti and the two firefighters found the 16' x 7' single panel 3/4" plywood door weighing about 250 pound had closed trapping them inside. Conditions worsened due to the hinged garage door to the home being propped open and the 60 mph winds hitting the Charlie side on the home.

In attempts to open the garage door, one of the firefighters reached up to find the overhead door release but was unable to raise his hand about three feet due to the heat. One of the surviving firefighter reports that the garage door had been closed for 2-3 minutes before rescue efforts had begun. Attempts were made from exterior crews to gain access to the garage door at around 1:05 am using axes, the Chicago Door Opener and gas powered saw. However, the resiliency of the door and inability to use gas powered tools due to the deteriorating conditions choking out the saws, caused a delay in rescue operations.

Around 1:10 am, a large enough hole was produced in the lower corner of the garage and one of the firefighters was pulled out and conscious. One minute later, the garage door was opened completely and Lt. Mambretti and the other firefighter were found unconscious face down with their SCBA mask disconnected from their regulators. Lt. Mambretti and the two firefighters were taken to the hospital. One firefighter sustained burns to his lungs and third degree burns to his hands and body. The other firefighter was placed in a medically induced coma and was permanently blinded. Lt. Mambretti succumbed to his injuries and was pronounced deceased at the hospital.

- It is the first in companies job to secure the garage door. This can be done by using vise grips, propping door open with ceiling hooks or ladders, disabling the electric motor, securing the drive chain, disabling the door track, etc.
