TRAINING NOTES

DIVISION OF TRAINING

Emergency Apparatus Accident | Safe Driving Practices

Emergency Apparatus Accidents

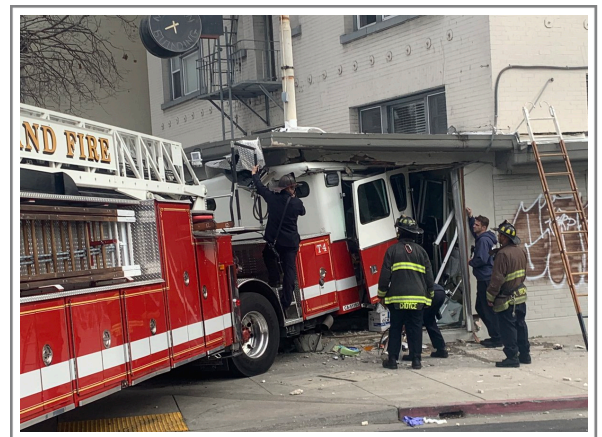
Oakland, CA

Around 12:40 pm on February 26, 2022, OFD Truck 4 responded to a reported working fire. While en-route to the reported fire, Truck 4 attempted to proceed through the intersection of Grand Ave and Perkins following behind another responding rig, however was impeded by a car crossing in front of their apparatus. In attempts to avoid colliding with the vehicle, Truck 4 redirected and crashed into a building. Three of the firefighters on board sustained moderate injuries and were transported to the local hospital. No civilians were injured in the crash.

- The key to rapid response is getting out of the station in a timely manner, not driving at excessive speeds.
- **Basic Speed Rule:** never exceed a speed which is reasonable and proper for the existing conditions even when the law permits a speed faster than you are driving.
- **Don't use Auxiliary Braking Systems (retarder or Jake brakes) when streets are wet**
- **Confirm clear intersections even when following another responding unit**
- **Whenever driving on city streets, the maximum speed for all Fire Department vehicles and apparatus is 35 mph.**
- **Emergency vehicles, responding with red lights and siren, shall come to a complete stop at all stop signs, red lights, and arterial controlled intersections.**
- **Whenever crossing against a red light, the maximum speed for all Fire Department vehicles and apparatus responding to an emergency (lights and sirens) call is 15 MPH.**

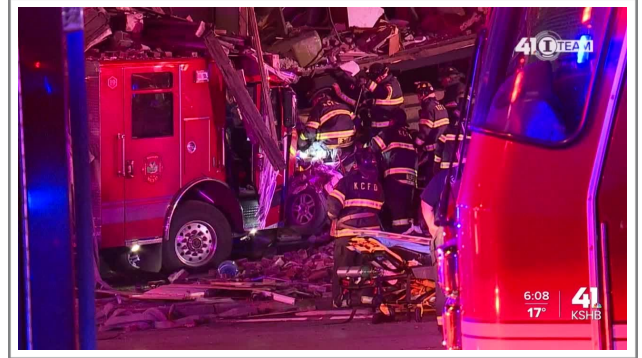
Kansas City, MO

At approximately 10:20 pm on December 20, 2021, Kansas City Pumper 19 was among several other apparatus responding to a reported structure fire. While enroute, Kansas City Pumper 18 notified dispatch via radio that they were available and close to the reported structure fire and requested to be attached to the response. Dispatch then placed Pumper 18 on the call and notified Pumper 19 to "stand down and remain in quarters." One minute later, Pumper 19 notified dispatch they were involved in a traffic accident involving another vehicle. Pumper 19 and a civilian SUV collided and the force of the crash caused both vehicles to slam into an adjacent brick building. None of the firefighters on board were injured, both occupants of the car were killed as well as one pedestrian found under the partially collapsed building.

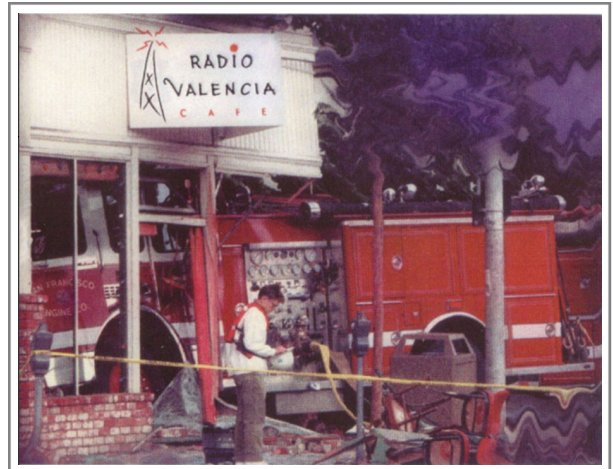
San Francisco, CA

At approximately 5:30 pm on June 28, 1995, Engine 24 and Engine 11 were responding to a box at 23rd Street and Treat Ave. One of the engines was responding from the firehouse while one

was responding from the location of another call. While enroute, Engine 24 and Engine 11 were involved in a collision at the intersection of Valencia and 23rd Street, just seven blocks away from the reported fire. The crash sent one engine through the wall of the popular Radio Valencia Cafe. Eight firefighters were moderately injured and released from the hospital. Radio Valencia Cafe suffered severe structural damage. One patron within the cafe sustained only minor injuries.

- It is the drivers responsibility to exercise safe driving practices, it is the officers job to enforce safety standards.
- Headsets limit surrounding audio, be hyper aware of oncoming rigs approaching intersections.
- There are many new officers in the field moving personnel into positions they don't usually fill. Become familiar with members abilities to fulfill those functions and set performance expectations early in the watch
- Always be aware of other responding apparatus and to follow regular response route to provide predicability.
- Pay particular attention when responding from a location other than quarters

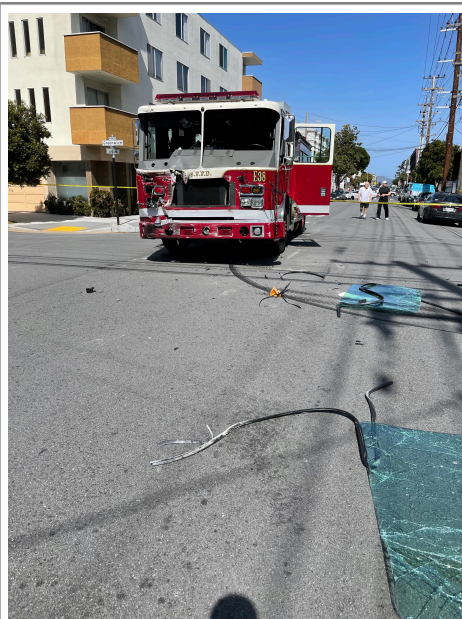
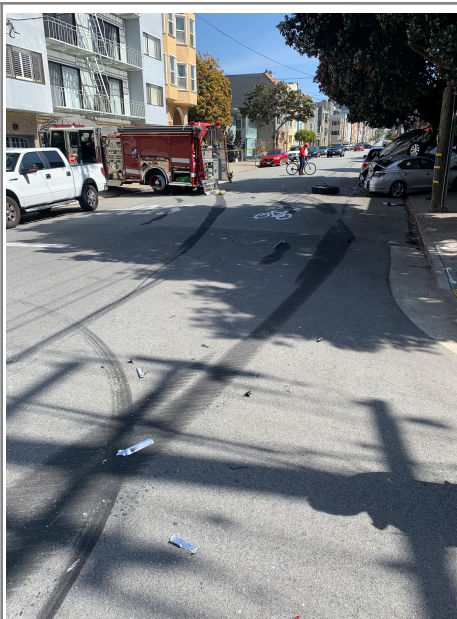
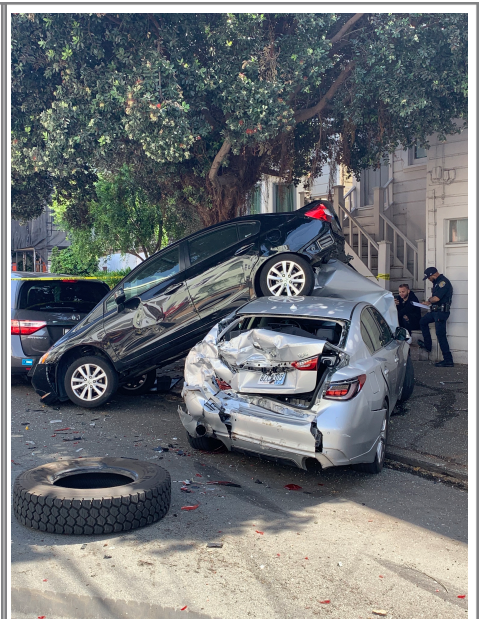
San Francisco, CA

On March 18th, 2022 at 1155 hours, BOX 3251 was struck at 1803 Broadway between Gough and Octavia. The following units were dispatched at 1157 hours; E38, E41, E16, T03, T16, B04, B01, D2, RS2 and KM111. At the time of dispatch, Engine 38 was shopping at Marina Safeway and Engine 16 had just gotten back from a surf rescue drill a couple minutes prior and were responding from Station 16. While enroute from their respective locations, Engine 16, heading east on Greenwich, and Engine 38, heading south on Laguna, met at the intersection of Greenwich and Laguna and collided. The impact took place between Engine 38's front bumper and Engine 16's driver side rear dual tires. The crash caused Engine 16's back tires to be lifted off the ground and swing out and into two unoccupied parked cars before coming to a rest at approximately 100' past the intersection. Engine 16 sustained major damage which included the loss of a rear wheel and considerable structural body damage on the driver side due to the impact with Engine 38 and officer side due to the impact with the parked cars. Engine 16 was unable to be driven following the accident and had to be towed. Engine 38 sustained the majority of the damage to its officer side bumper. On impact, Engine 38 lost both driver and officer windshields and the force of the impact ripped off the bell and caused it to become lodged in Engine 16's body. Engine 38 was able to be driven away following the accident. All occupants of both Engine 38 and Engine 16 walked away with minor injuries, no civilians were hurt.
